BAKER (MICHAEL) JR INC BEAVER PA
NATIONAL DAM SAFETY PROGRAM. CARROLL DAM (STONY CREEK NUMBER 10--ETC(U)
AUG 78 M BAKER

Name Of Dam: CARROLL (STONY CREEK NO. 10)
Location: SHENANDOAH COUNTY, STATE OF VIRGINIA
Inventory Number: VA 17102

LEVEL II
PHASE I INSPECTION REPORT
NATIONAL DAM SAFETY PROGRAM

Name of Dam: Carroll
State: Virginia
County: Shenandoah
Stream: Alum Run, Tributary to Stony Creek
Date of Inspection: 2 June 1978

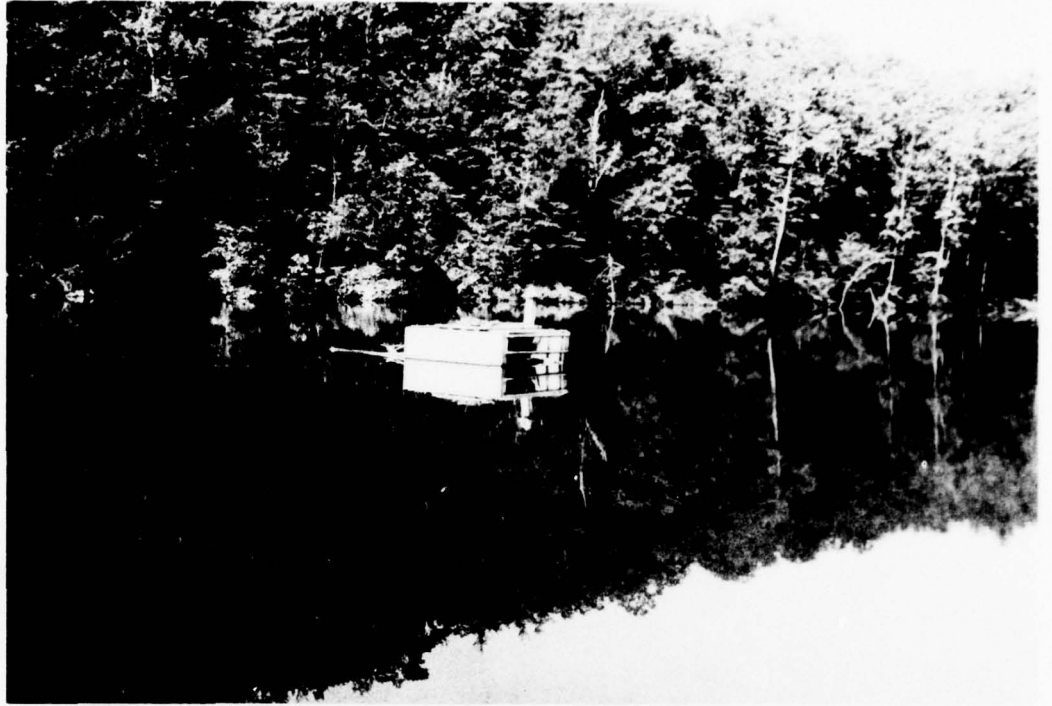
PHOTO 3

3.1.3 Appurtenant Structures: At the time of the inspection, the riser crest contained a great deal of lodged debris as shown in Photos 3 and 4. It is understood that the Lord Fairfax Soil and Water Conservation District maintains the riser and is responsible for clearing the trash racks. This cleanout should be done in the near future.

It is recommended that stability analyses be performed using the as-built embankment section. The minor erosion on the downstream slope of the embankment and on the left slope of the emergency spillway should be repaired as part of the annual maintenance program of the Lord Fairfax Soil and Water Conservation District. The primary spillway riser should also be cleaned of trash and debris.
